Does it Look Good – Is it Safe? –part 2

Floor Safety at Birmingham City University (BCU)

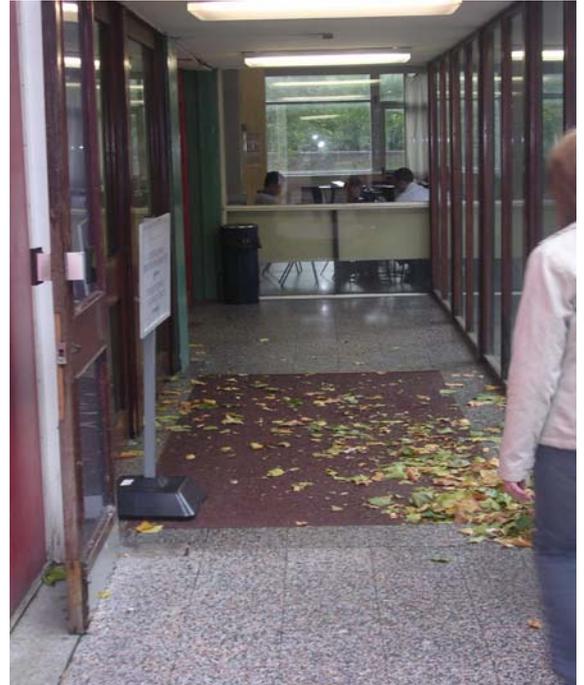
From the research standpoint, it was appropriate to examine conditions at the external entrance to the Baker Building although, as Chris pointed out, there had not been any reported Slips, Trips or Falls there for five years! This view shows what happened in the entrance corridor, when it rained, and further inside there was a 'plume' of water on the terrazzo flooring. The existing mat in the door-well was not doing an adequate job! Even further inside the building were vinyl tiles and the HSE Roughness Meter confirmed their slip resistance was particularly low when wet and this constituted a "High Risk" on the HSE's **Slips Assessment Tool (SAT)**. This is a computerised programme that Quantifies these elements of 'Slip Resistance' (<http://www.hsesat.info/>): -

Original Baker Entrance Corridor –
with Leaves and Water when it rains!

- The mat removes dirt but not water from footwear
- The hinged, outer lobby doors are heavy and often held open, so that the entrance corridor fills up with leaves
- When it rains, a 3m plume of water is created inside the inner doors, in the Entrance Hall
- A warning cone and occasional dry wipe does not remove the hazard adequately in this busy entrance accommodating 2,000 pedestrians per day!

- Improve the Cleaning Methods and Training of cleaners, particularly on wet days
- Purchase loose barrier mats to be inserted after the existing mat well to reduce water contamination. (The resultant trip hazard had to be minimised!)
- Investigate a replacement for the mat in the well. This choice took several months.
- Identify structural improvements to the entrance area.
