Members' Corner

A presentation on the Safe Use of Quick-Hitch devices on Excavators.

Bob Cole, Morgan EST

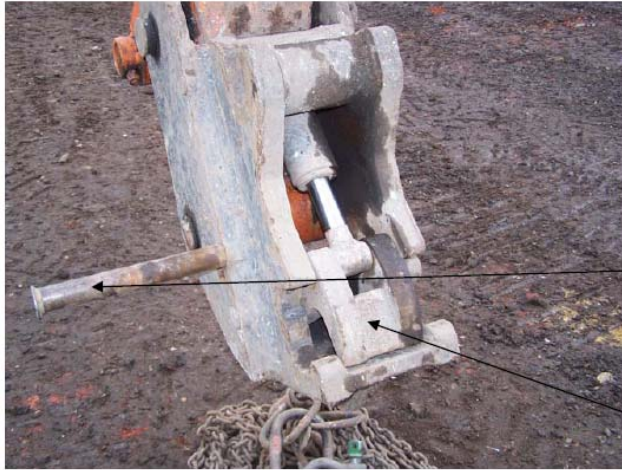
Safety pin

Latch in closed position

like buckets, to the dipper arm of an excavator. In order to maximise the productivity of the machine, a driver may operate this device as many as 30 times each day and the accidents occur when the device safety pin is inadvertently left out afterwards.

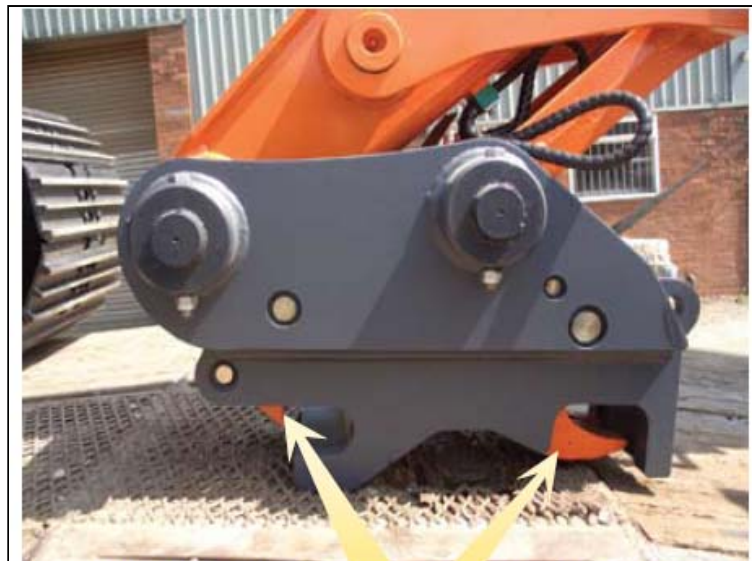
Hydraulically operated pivot pin retaining mechanisms (in orange)- the hydraulic hose connections can be seen at the top of the picture.

The problem may be partially overcome by an improved version of the device called a "Fully Automatic Quick Hitch", illustrated here. These are controlled

from the cab and eliminate the need for the driver to dismount and it is often necessary to fully crowd or scroll the attachment to fully engage the safety device. However, on all types of Quick Hitch, it is still necessary to check correct engagement by taking the attachment through a full operational rotation at full speed. This is humourously referred to as a “Shake, Rattle and Roll” test that must be carried out in isolation to any other traffic or worker movements. A full visual examination to check engagement must be made after this test.
