# Learning from Accidents, Incidents & Near Misses

**Mike Pearson @ SATS LTD (NEBOSH, BOHS & PTLLS Qualified)**

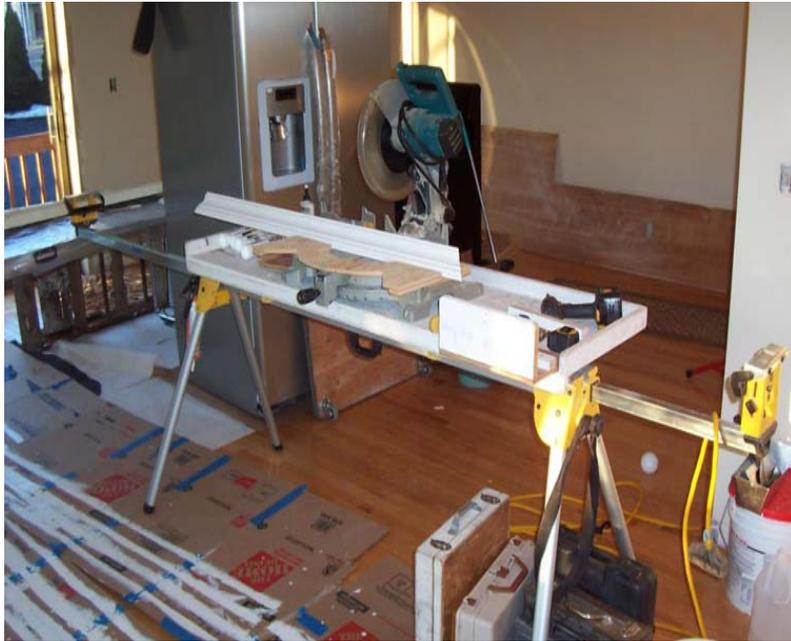
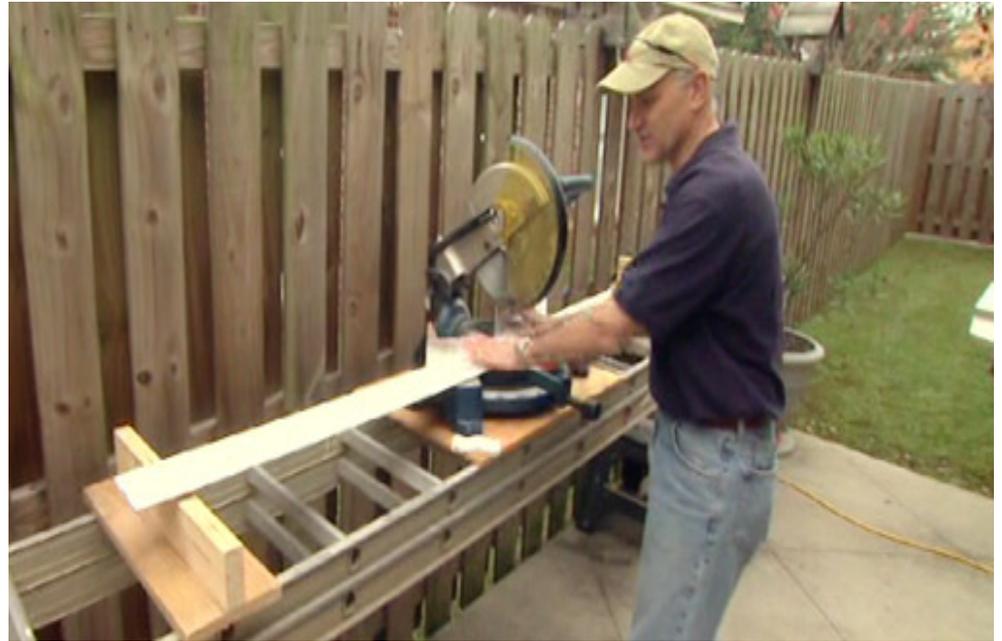
1. A recurring one with 4 serious injuries to hands, arm & fingers involving chop saws.

- Self-employed workers sharing saws with faulty parts/ guards to save having to get their own out of the van, using them to cut long lengths of timber without sufficient support, their hands too close to the blade and having to apply excessive downward pressure to hold the material.

- Workplace supervision did not carry out full inspections of sub-contractors equipment, expecting that the tools were OK to use.
- In two incidents workers were forced to wear gloves due to “Principal Contractors blanket rules”, whereas both HSE & CITB guidance stipulates that “gloves must not be worn when using machinery with serrated blades”. This was stated within the RAMS, but the contractors were made to amend the RAMS to state that gloves must be worn!

- In one of the accidents the glove drew with arm into the saw & the IP had to endure bits of glove being taken out of his injured arm & hand with a pair of tweezers!

- **Resultant actions: Management must inspect all equipment, whoever owns it**
- **Watch users in action to spot unsafe practices**
- **Do not wear gloves with serrated cutters**

- **Never cut unsupported items with items that are less than 500mm long to be clamped in position**
- **Deliver tool box talks to remind everyone of the actions to take as often as necessary**
